## About Prediction of Collapse Generated Locations Using Groundwater Aeration Sounds

Forestry and Forest Products Research Institute Yasuyuki Tada

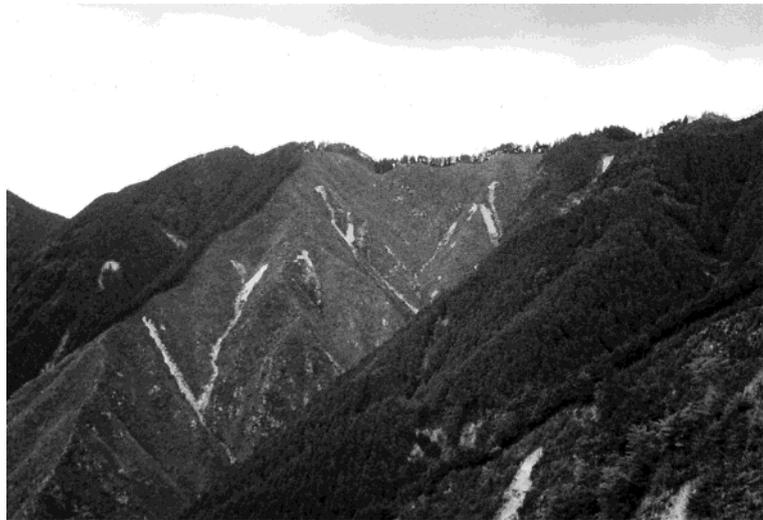
Picture-1 Example of Shallow Landslide Occurred at Mountain Region

However, in actual shallow landslides, as shown in Picture-1,

there are some which occur around catchment boundaries where there is almost no catchment area and there are some which occur on ridge type slopes. On the other hand, when thinking about the timing of rainfall and collapses, it is known that collapses occur near the peak of rainfall intensity. However, it has been pointed out that the times of estimated collapses, calculated numerically using a catchment model which assumes the soil layer is uniform, lag behind the actual times of occurrences of collapse (Hiramatsu et al. 1990). Furthermore, it is empirically known that even if permeability and water retentivity are strictly measured, the results of infiltration analysis do not match the observable data at the local site. These reasons seem to show that non-uniformity in underground and the rainfall infiltration process originating from that are not considered as important (Ex. Tada et al 2002, Tsutsumi et al. 2005).

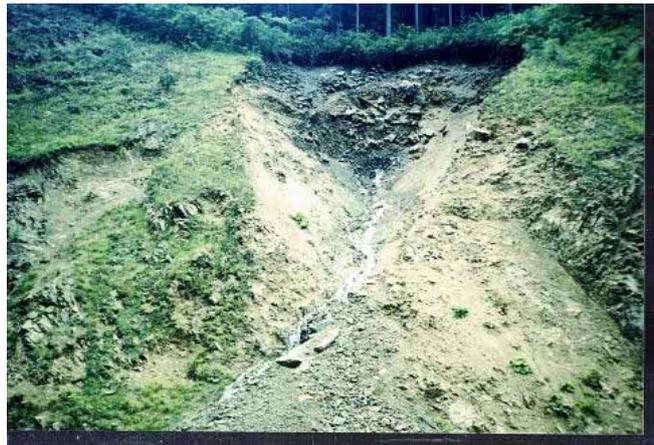
Picture-2 Spring Which Can Be Seen at Collapse Area (provided by Forestry Research Center Tottori prefecture Kan Koyama)

In order to predict locations generating collapses, it can be understood from seeing the following 2 pictures that non-uniformity should be taken into consideration. For example, in collapse areas springs, shown as in Picture-2, are often confirmed (e.g. Kawaguchi et al. 1951). In addition, as shown in Picture-3, we observed piping holes, from which water flowed on the scarp of the collapse, even though there is no spring (e.g. Ota et al. 1981). Meanwhile, blow-offs, stoppages, and turbidity of springs are known as precursory phenomena of collapse. In this way, since long ago it has been thought that there is a close relationship between water paths and collapse phenomenon. However, since there is no method to efficiently detect distribution of water paths at local sites, there are a great many factors which are unclear about the causal correlation between water paths and collapses.

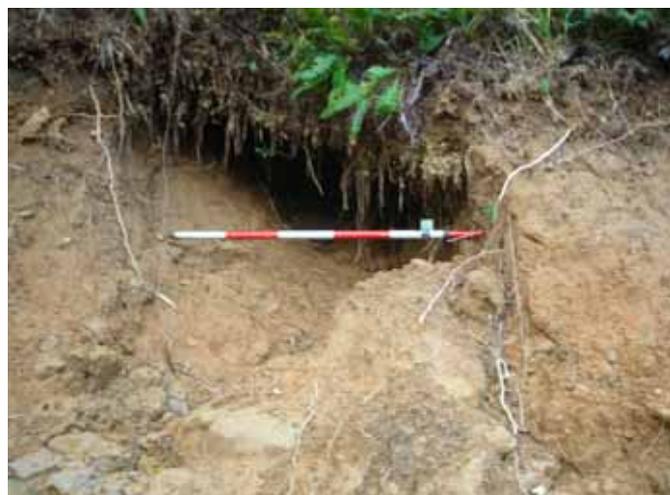
Picture-3 Piping Hole Seen in the Collapse Area

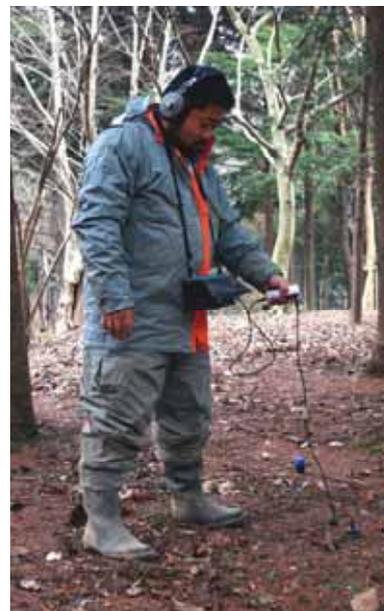
Picture-5 Showing Groundwater Aeration Sounds Being Measured

The groundwater aeration sound measuring device is shown on Picture-4 and the measurement scene is shown on Picture-5. The groundwater aeration sound measuring device consists of 1) sensor, 2) finder, 3) headphones, 4) recorder. The functions of each part are as follows.

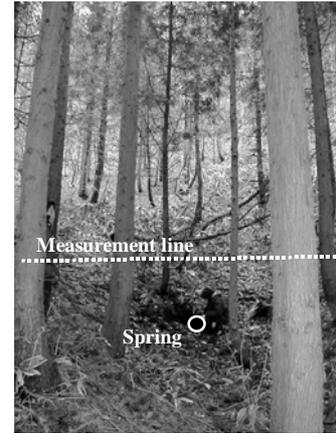
3) Hiruzen C (Picture-8): We carried out a survey, targeting springs developed on a colluvial deposit in the spur. The surface layer was covered by about 2 m of Andosol and the lower layer consisted of tuff breccia. A spring is situated on the boundary of the Andosol soil layer and tuff breccia and the spring flows during heavy rainfall or snow melt. During the surveys, no spring was seen but there was some moisture.

Picture-8 Appearance of Vicinity of Spring Point in Hiruzen C

In the surveys, we set a measurement line which crossed water paths as shown by the dashed lines in Picture-6 to 9, and measured the groundwater aeration sounds at 0.5 m to 2 m intervals on this measurement line. In addition, although the measuring method is the same as described before, but because winds etc. unexpectedly blew strongly and generated noise, we made sure not to carry out measurements during those periods. In addition, for measuring frequency, we used frequency bands of 400 to 1200 Hz which are less affected by wind.

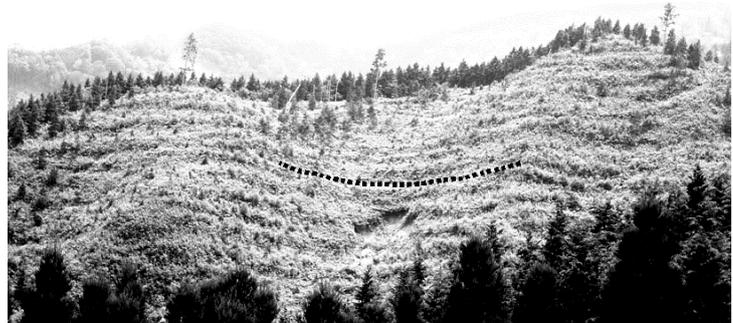
There is a shallow landslide at one location of cutover area of Japanese cedar. The geographical feature of the ground surface is water catchment topography. The collapse is 10 m wide and has a 1 to 1.5 m collapse depth and at the boundary there are slides in the bedrock. Traces of water flow were not confirmed at the scarp but there were spring points approximately 15 m below in a direction downstream of the collapse. It is thought that the saturation zone expanded upstream of the slope from the vicinity of this spring point and collapsed.

Picture-10 A Shallow Landslide Occurred at Natural Slope A

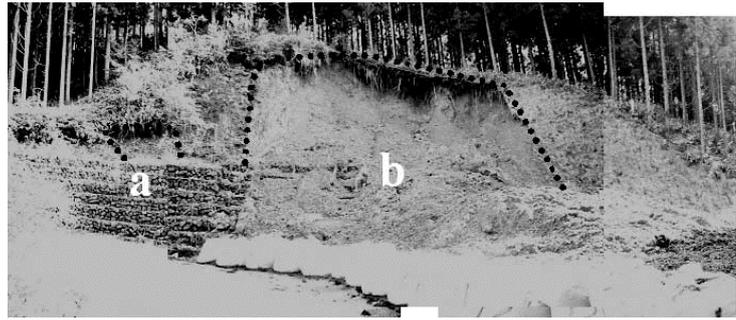
- Collapse a: 3m wide and approximately 0.5 m deep and is created by a thin slide of surface soil on the slope. Since it is located in a valley, the soil layer was moist.

- Collapse b: 14 m wide and approximately 1m deep and was created by the soil layer on the bedrock sliding and liquidizing. There are 3 traces of water flow confirmed within the collapse area. All groundwater aeration sounds are loud within collapse area. In addition, in collapse b, there are three traces of water flow confirmed. Peaks of groundwater aeration sounds are well aligned with them.

Picture-15 Slope Landslide Occurred on Forest Road B

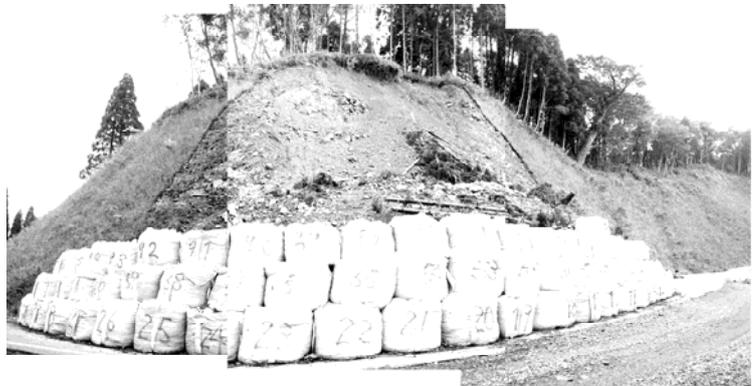
The collapse which occurred at ridge on forest road opened on ridge type slope is 18 m wide and 1.3 m deep. The geological features consist of granodiorite. Although no spring was confirmed on the day of the survey, there are 3 traces of water flow confirmed.

Picture-16 Slope Landslide Occurred on Forest Road C
